NATIONAL PROGRAM FOR INSPECTION OF NON-FEDERAL DAMS
JAMES V TURNER DAM (R. (U) CORPS OF ENGINEERS WALTHAM
MA NEW ENGLAND DIV JAN 81

JAMES V TURNER DAH1
DOCUMENT IDENTIFICATION
JAN 1981 RI 01002

James V. Turner Res. Dam
Ten Mile River
East Providence, RI
CE# 27785 KG
DATE Jan. 1981 PAGE C-1

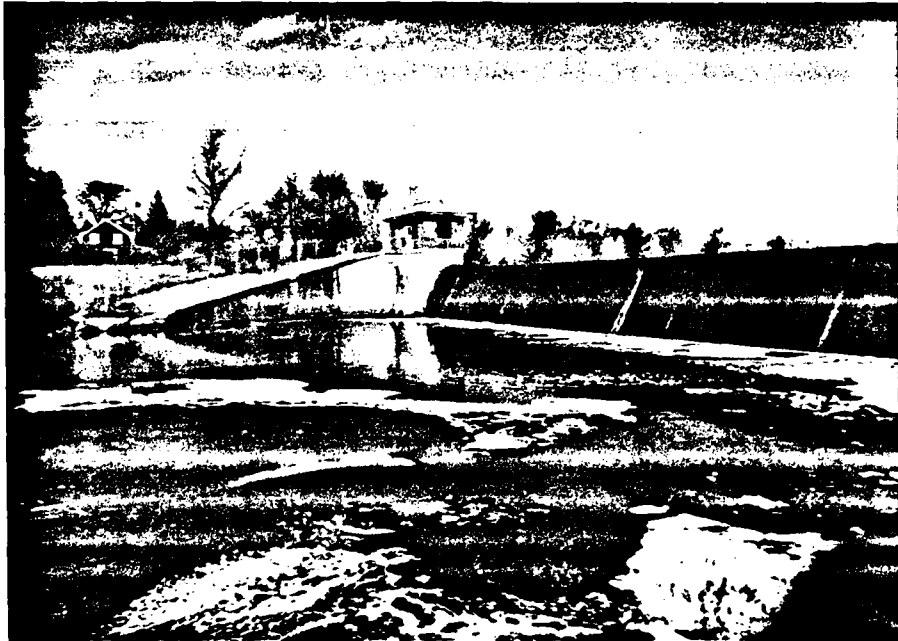
OVERVIEW FROM LEFT SIDE OF CHANNEL
(11-20-80)

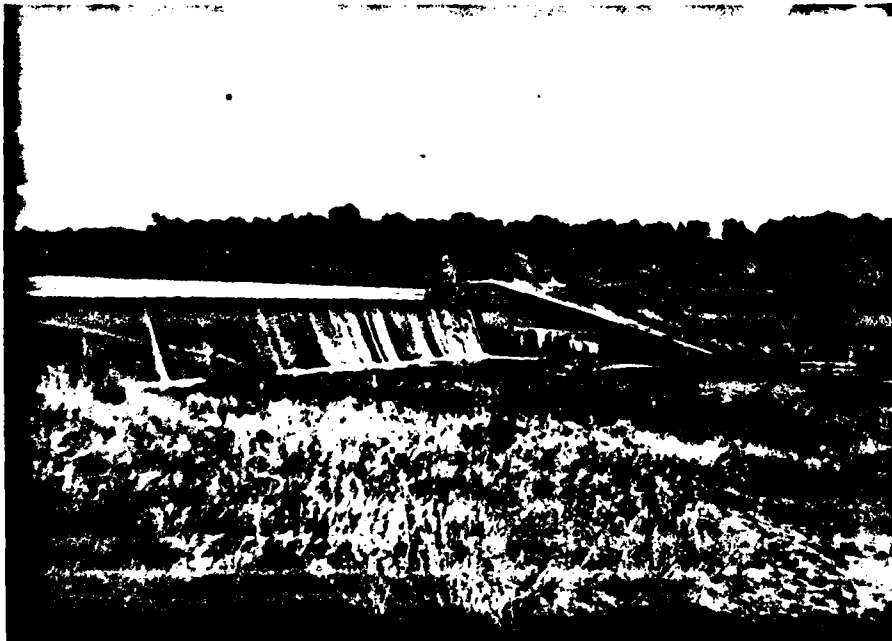
OVERVIEW FROM RIGHT SIDE OF CHANNEL
(10-8-80)

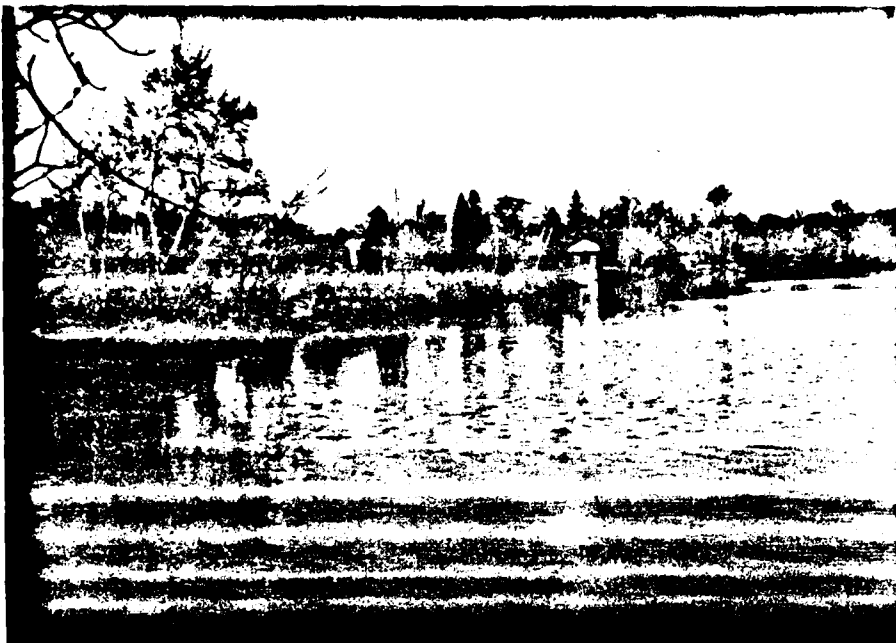
Top of Earth Dam - The grass cover on the dam is approximately 2 feet tall except for where trespassing along the top has worn a path. Some small trees and brush are also growing along the top (Photos 1 and 4).

Photo 1 - Upstream slope from left abutment.
(11-20-80)

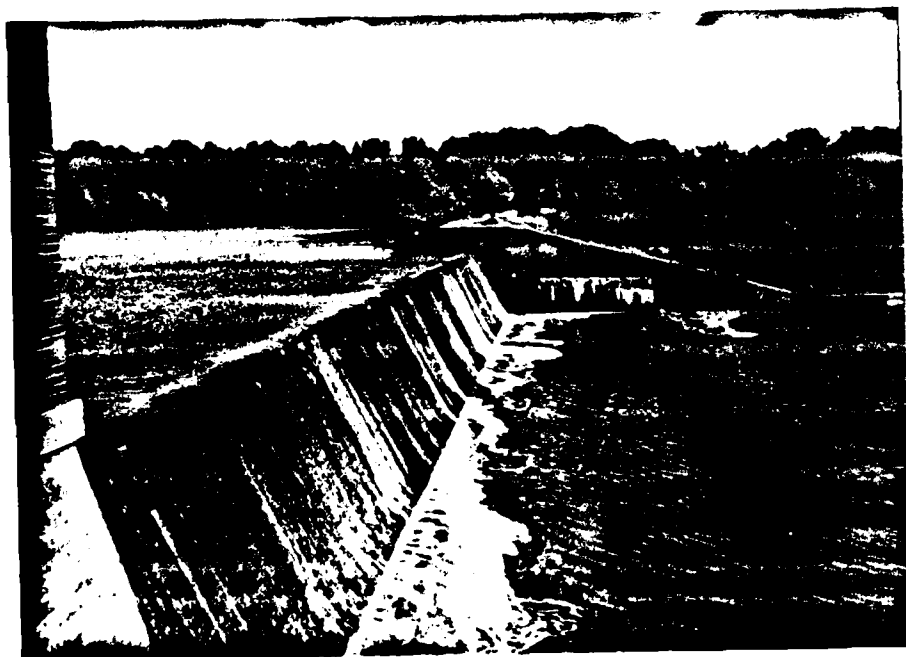
Spillway - Water was flowing over the spillway at the time of the inspection; therefore, the extent of the inspection was limited. The spillway crest shows no signs of irregularities (Photo 4). A concrete stilling pool extends from the toe of the spillway for a distance of about 30 feet. With water flowing over the spillway, the condition of the stilling pool could not be observed. Cracks up to 1 inch wide are present in the concrete training walls at construction joints and where the walls change slope or direction. The left wall has some spalling and deterioration on its face and above the drain outlet and the storm sewer outlet. The downstream end of the right wall is deteriorated and some minor spalling is present on the wall face (Photos 4,5,6).

Photo 4 - Spillway and earth dam. (11-20-80)

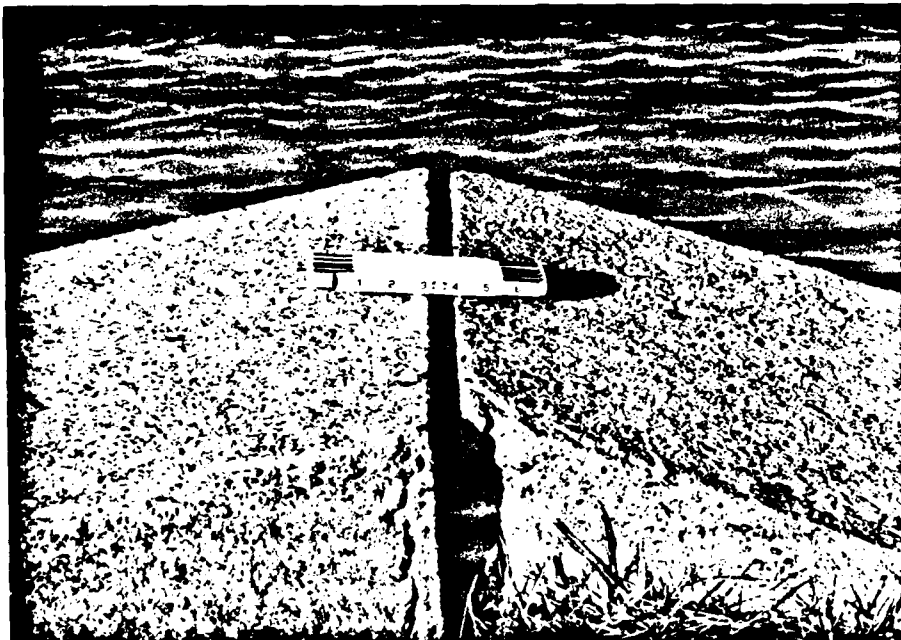
Photo 5 - Separation and displacement of
left spillway training wall.(11-20-80)

5. The possibility of seepage contributing flow to the back-channel at the toe of the embankment should be investigated.
6. Cracks in the concrete structures should be filled and spalling repaired to prevent further deterioration of the concrete.

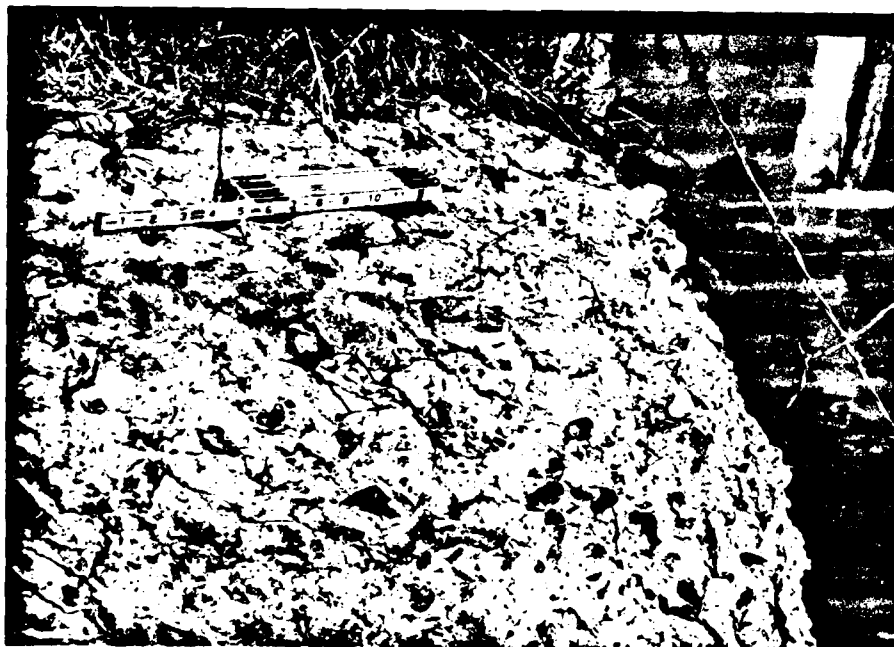
Photo 6 - Deterioration of downstream end of right
spillway training wall.(11-20-80)

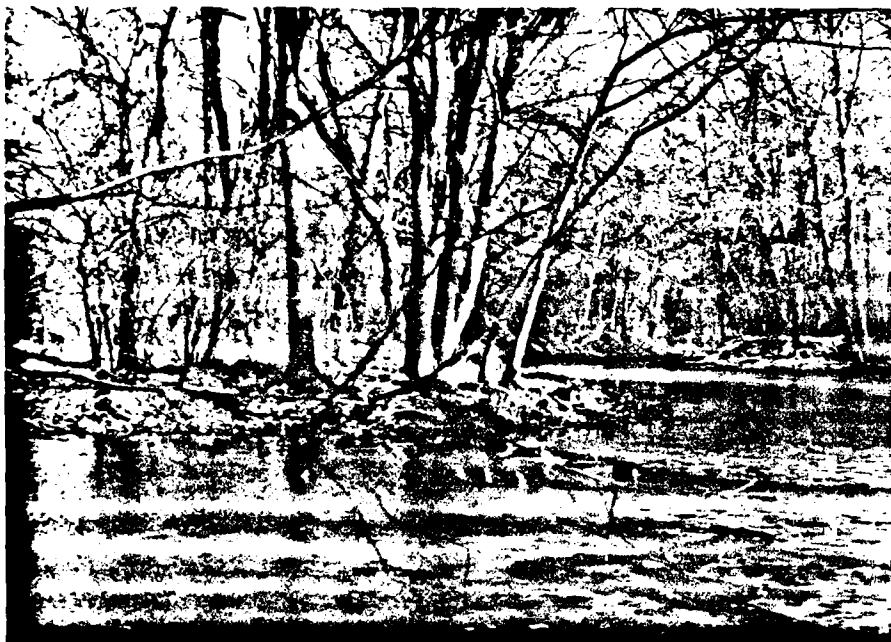
Photo 7 - Backchannel at toe of earth dam. (11-20-80)

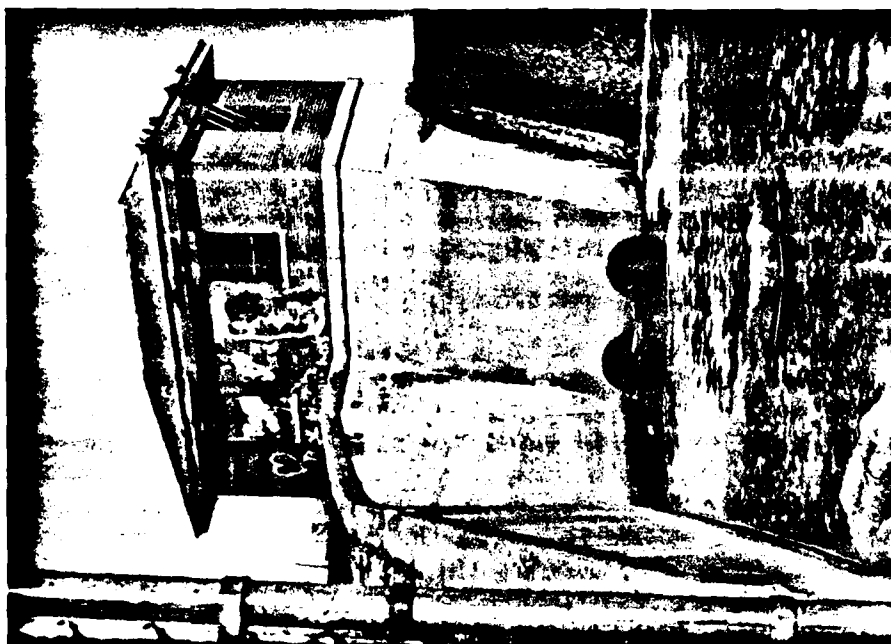
c. Appurtenant Structure - The brick gatehouse is in poor condition. All the windows are broken, graffiti covers the walls, wood trim is broken, roof shingles are torn off, etc. (Photo 8). The door has been removed and the opening sealed with concrete block and mortar. One window on the downstream side has been covered with a steel plate to prevent trespassing. The handwheels have been removed and stored by the East Providence Water Department to prevent vandals from opening the sluice gates. The low-level outlets could not be inspected because of the condition of the gatehouse. For all practical purposes the gatehouse has been abandoned.

Photo 8 - Gatehouse and outlet structure.
(11-20-80)
